WIPP Underground Fire Accident Investigation Summary February 5, 2014

Ted Wyka
Chairman, Accident Investigation Board
March 2014

The Accident

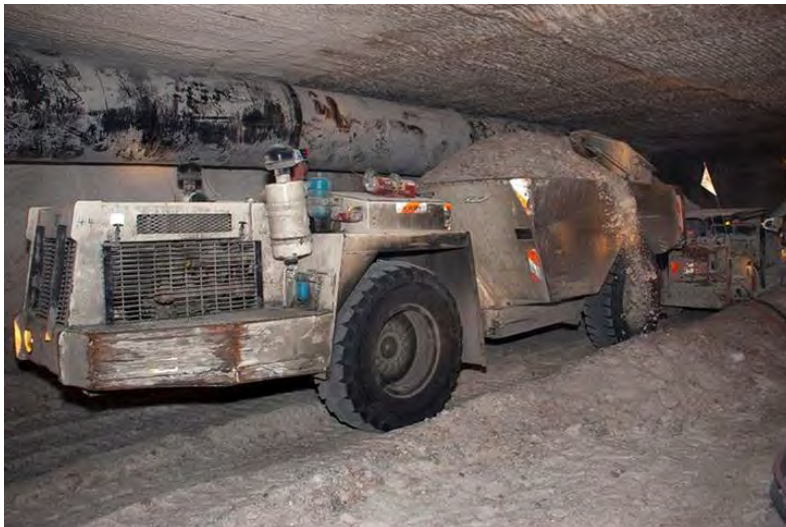
The EIMCO Model 985, 15 ton haul truck is a diesel powered vehicle used to haul salt from the mine. This is an aged piece of equipment, approximately 29 years old.

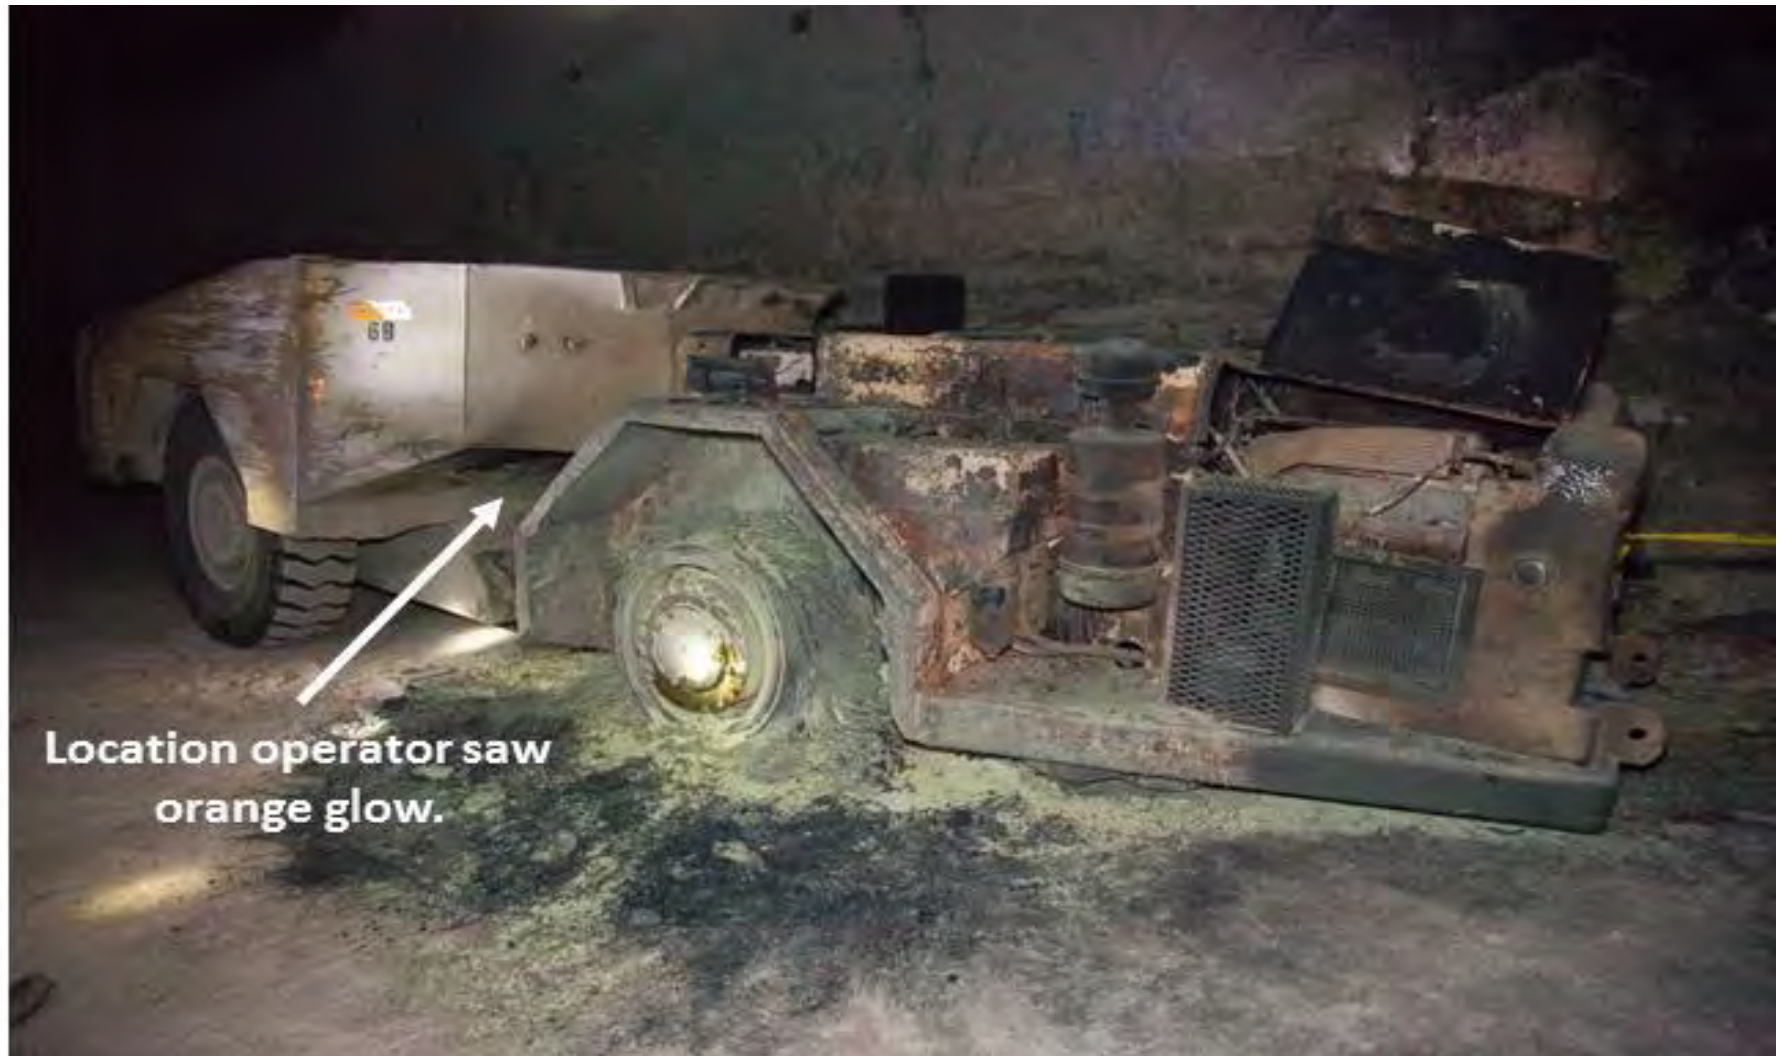
Salt Haul Truck

- **Operability and recognition of impaired critical safety equipment,** e.g., salt haul truck combustible build up; discontinued use of the vehicle wash station; chaining open of ventilation doors impairing remote operation; inoperable ventilation fans; out-of-service regulator/damper; inoperable mine phones ; emergency lights in the Waste Handling Facility; obscured evacuation reflectors; decision and analysis to disable the automatic fire detection and suppression system, etc. No method to readily understand status and impact of impaired mine safety related equipment.

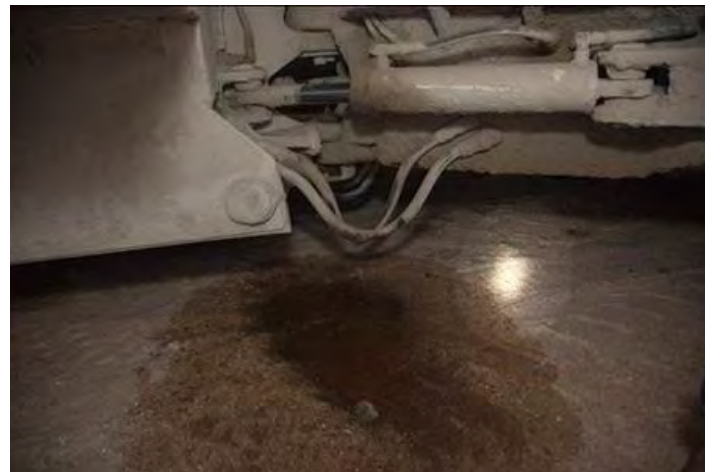
Hydraulic Leak under Sister Vehicle

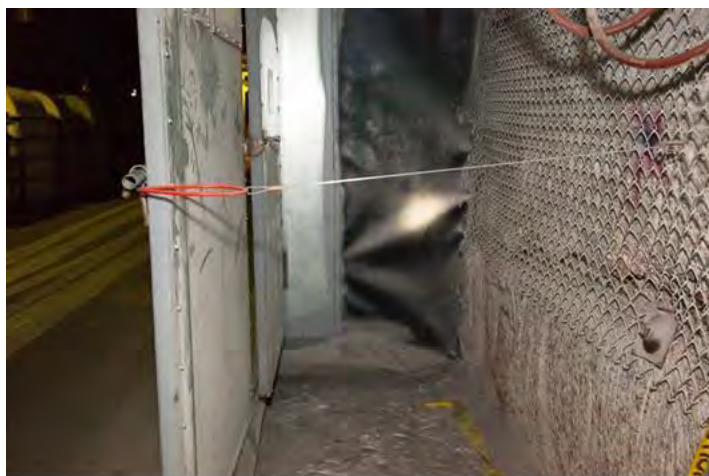
Air Lock Doors Wired Open

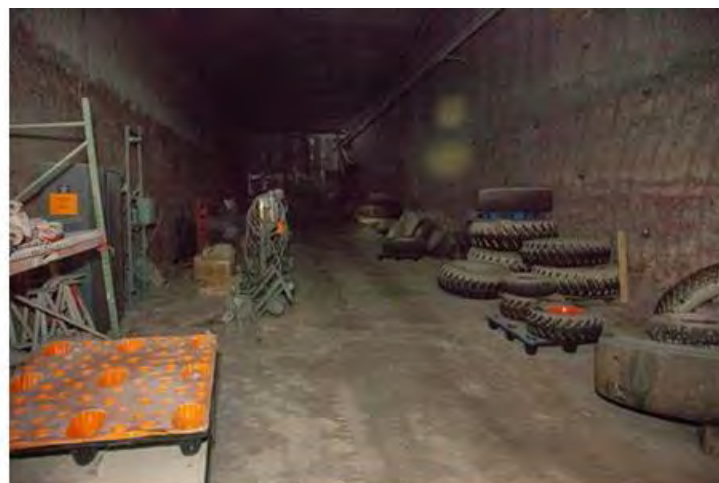
Combustible Loading in the Mine

- **Inadequate combustible loading program in the underground.**
- **Inadequate Fire hazard Analysis** (i.e. analysis of a fire near a shaft)
- **Maintenance, Emergency Management/Preparedness programs and NWP contractor assurance system (CAS) and CBFO oversight** were evaluated as **ineffective.**

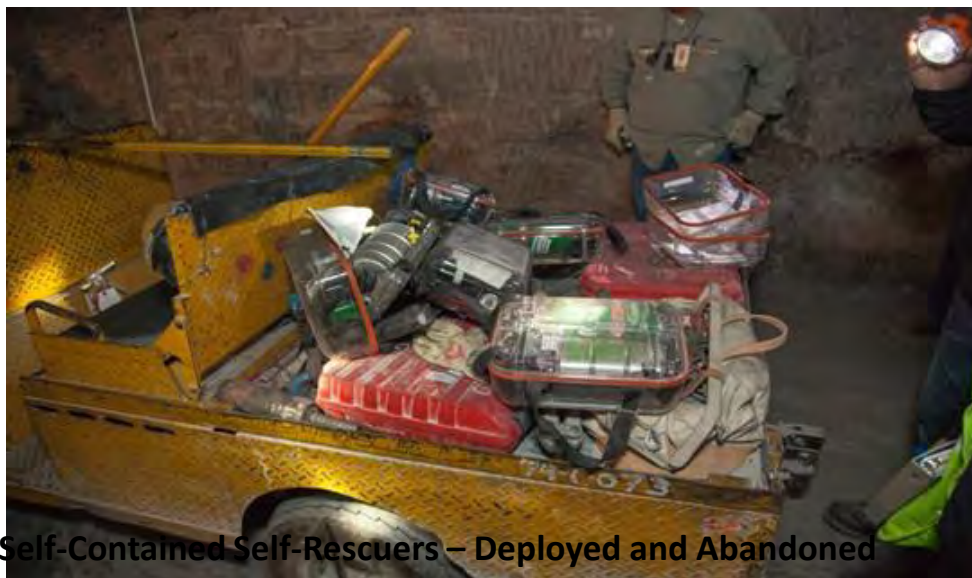
Self-Contained Self-Rescuers – Deployed and Abandoned

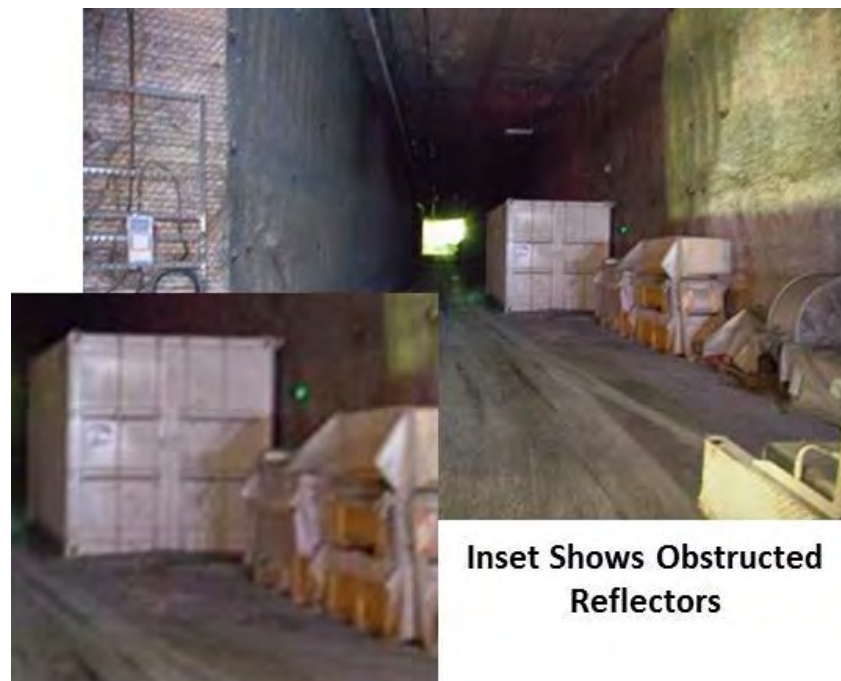
Inset Shows Obstructed Reflectors
